PRELIMINARY
KNKT.13.06.19.04

Aircraft Accident Investigation Report

**Merpati Nusantara Airlines
Xi 'An Aircraft Industry MA60; PK-MZO
El Tari Airport, Kupang
Republic of Indonesia
10 June 2013**

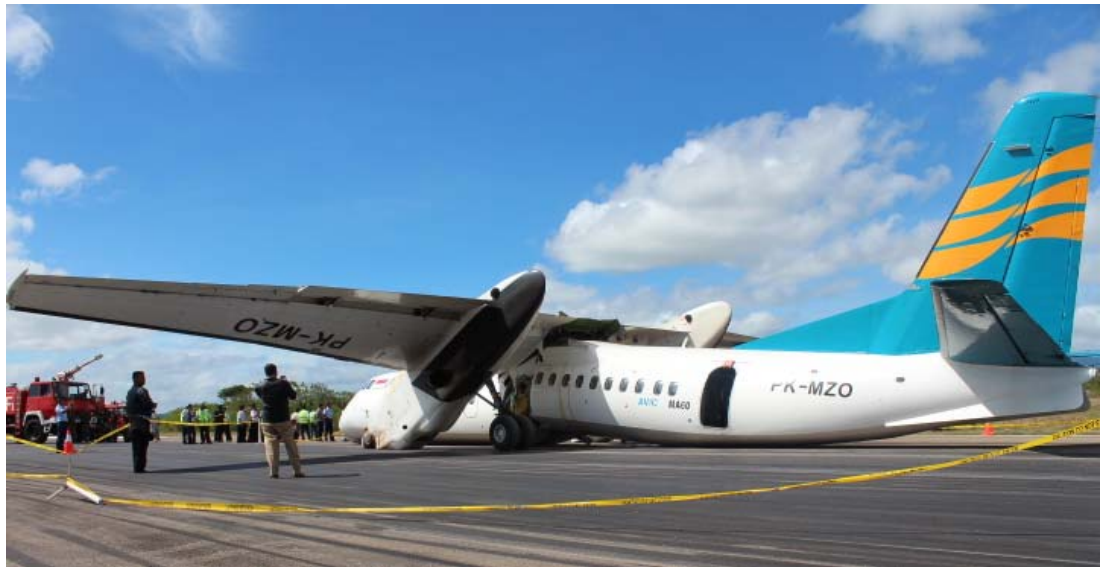
The aircraft was substantially damaged.

Figure 1: The accident aircraft

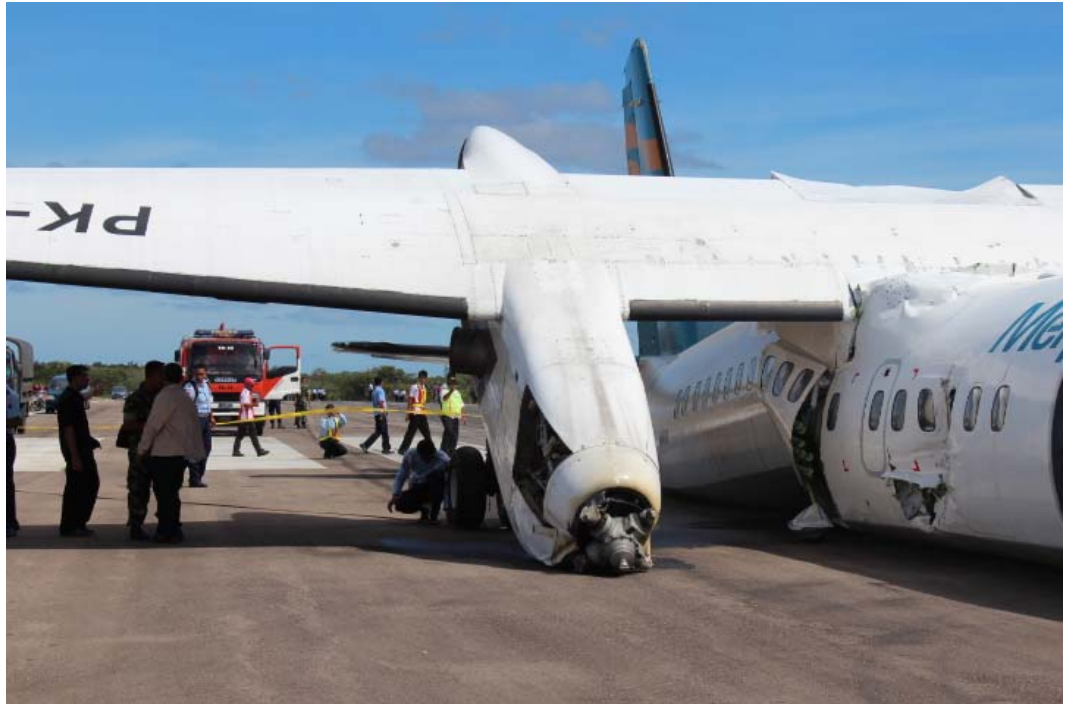
Figure 2: Damage on the right side of the aircraft

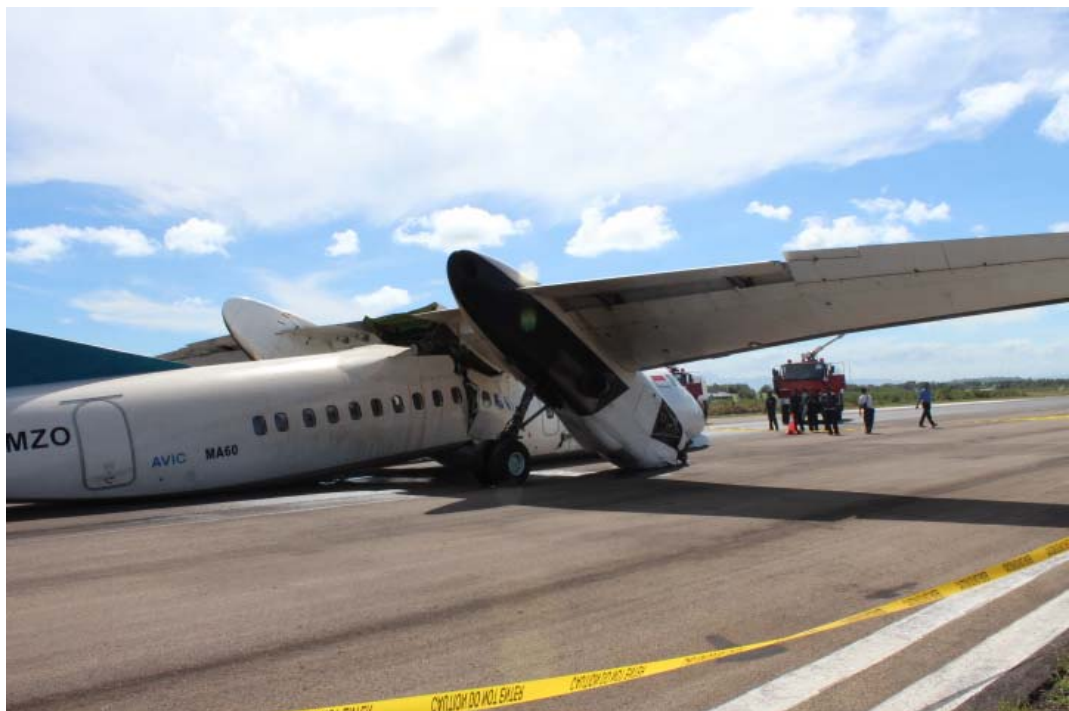
Figure 3: The rear right view of the aircraft

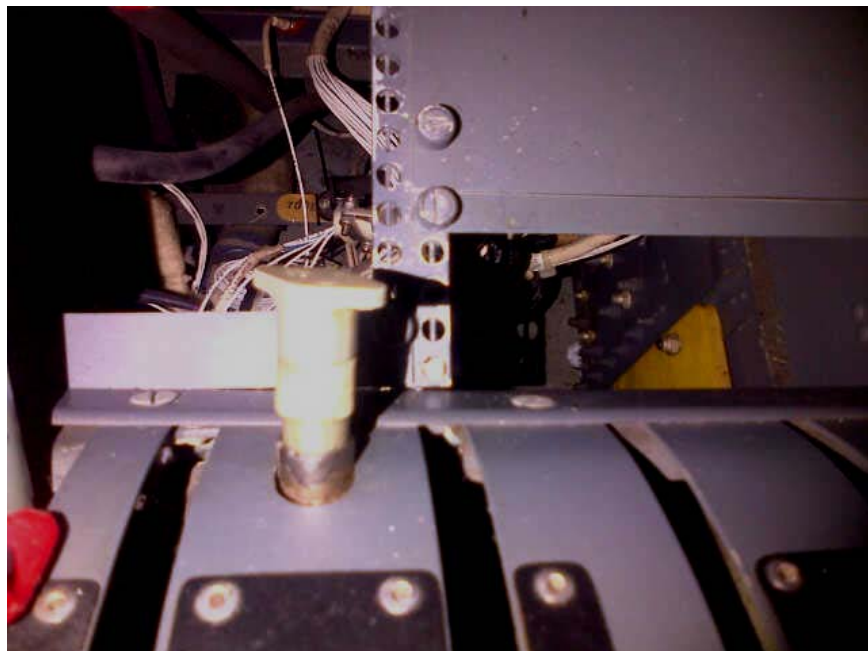
Figure 4: The electric magnetic stop found on “OPEN” position

On the accident aircraft, the electric magnetic stop was found in OPEN position. This situation was consistent to the company approach check list which stated “PL LOCK – OPEN”.

Observations on FCOM, Aircraft Maintenance Manual (AMM) and simulator did not find any caution light or aural warning whenever the electric magnetic stop selected to OPEN.

- f. The company approach check list contained item of “PL LOCK.....OPEN” which was not stated in the Flight Crew Operation Manual (FCOM) issued by the aircraft manufacturer. The power lever lock was found open.

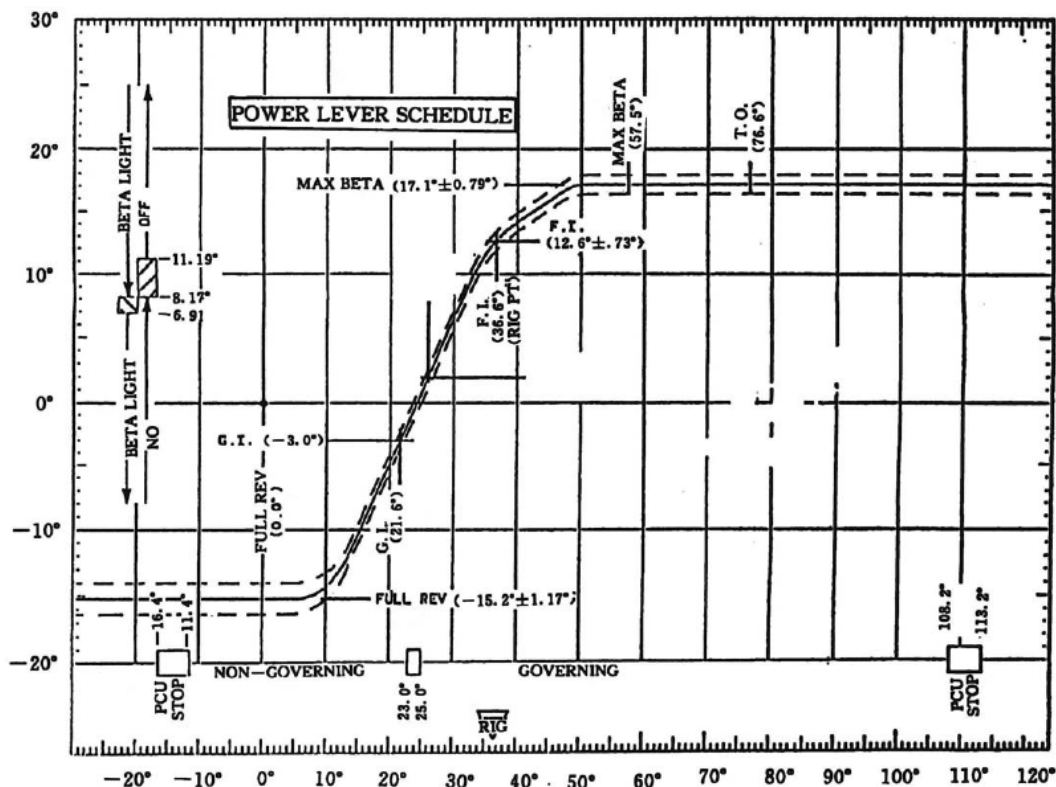
Figure 5: BETA operation curve of propeller

Refer to the graph (figure 5), the BETA range will set the propeller pitch angle below 8°. If the propellers pitch angle moves to BETA range will create significant drag.

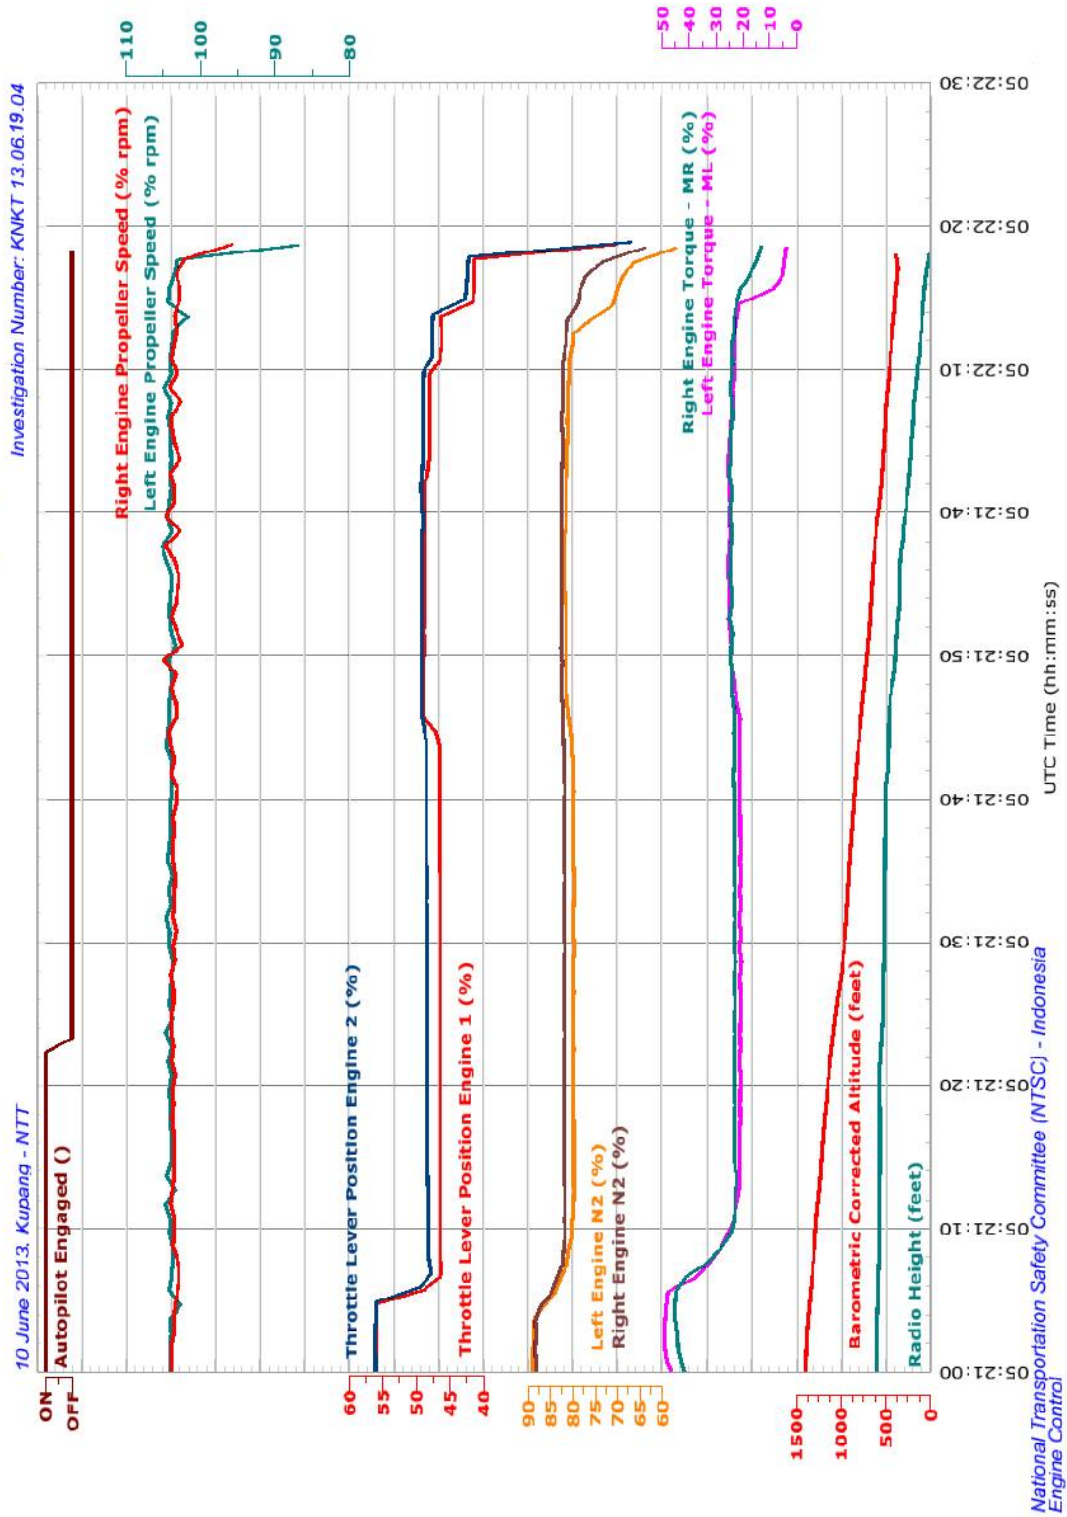
The FDR recorded that the left power lever was in the range of BETA MODE at approximately 112 ft and continued until touchdown.

Figure 7: FDR plot of main engine parameters

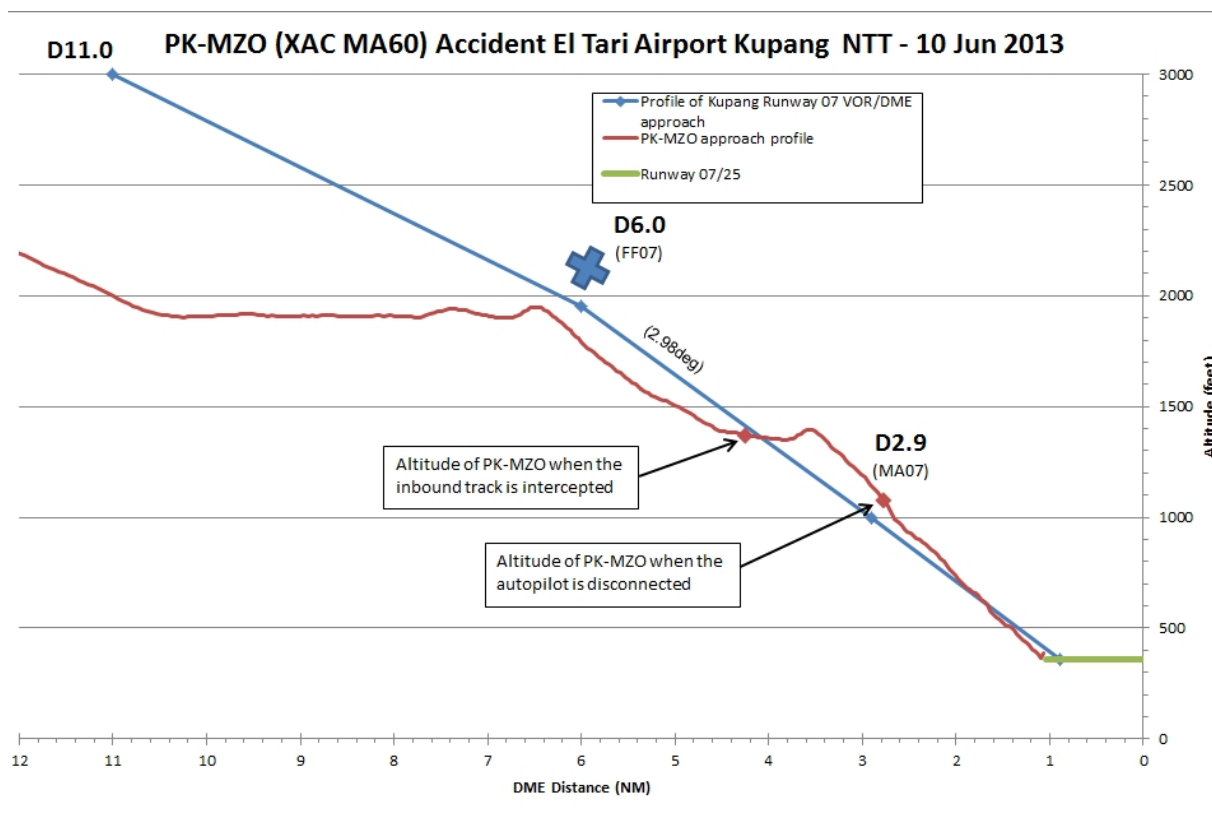
Figure 10: Comparison of published approach and actual profile

Figure 10 indicates that the approach was not on approach profile as published for runway 07.

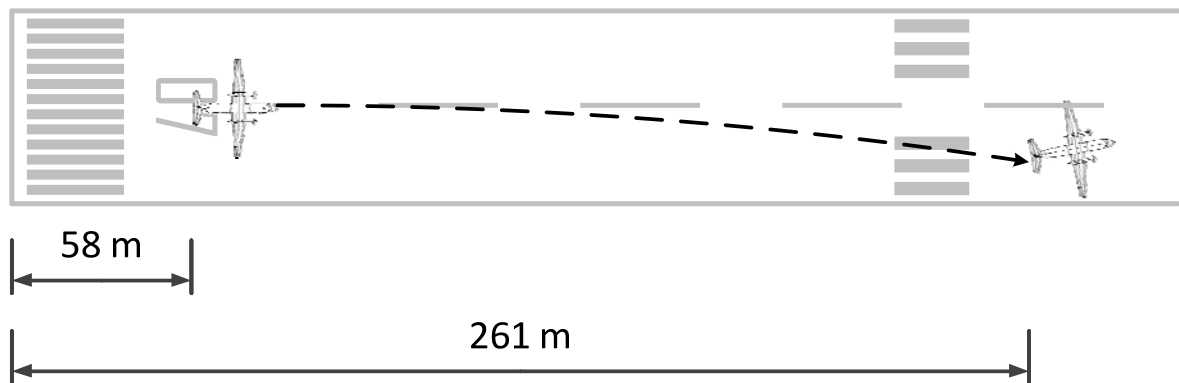
The main wheel touchdown marks found approximately 58 meters from the beginning runway 07.

The aircraft halted approximately 261 meters from the beginning runway 07.

Figure 11: The illustration of the accident

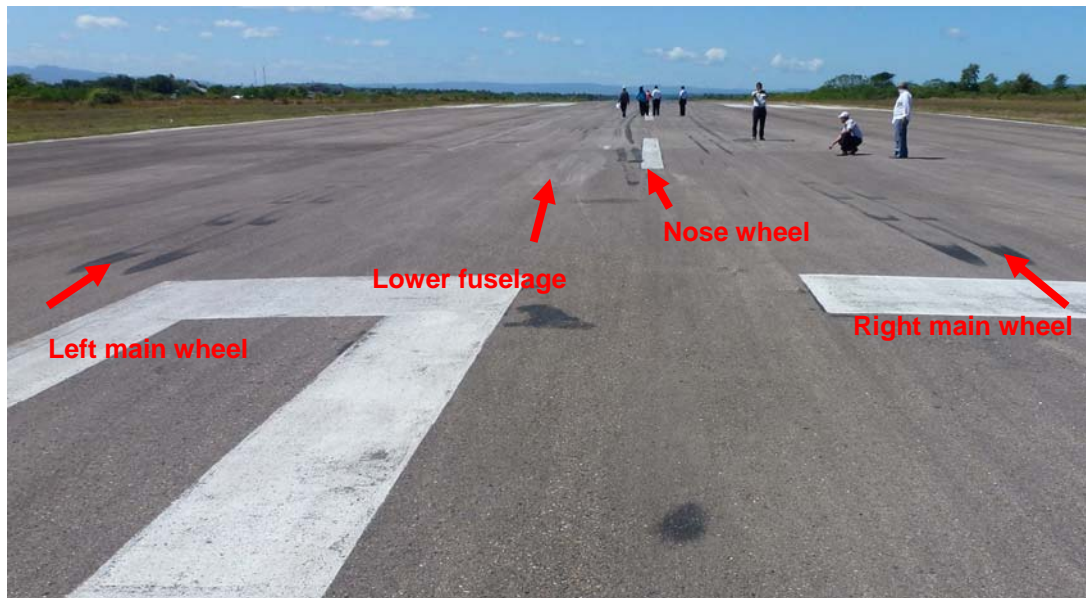
The marks on the initial touchdown showed that the lower fuselage impacted to the runway between the first marks of the main wheels and nose wheels (figure 13). The distance between the main wheels and the nose wheels marks was 7.5 meters while the normal distance was 9.5 meters.

Figure 12: The marks of the initial touch down

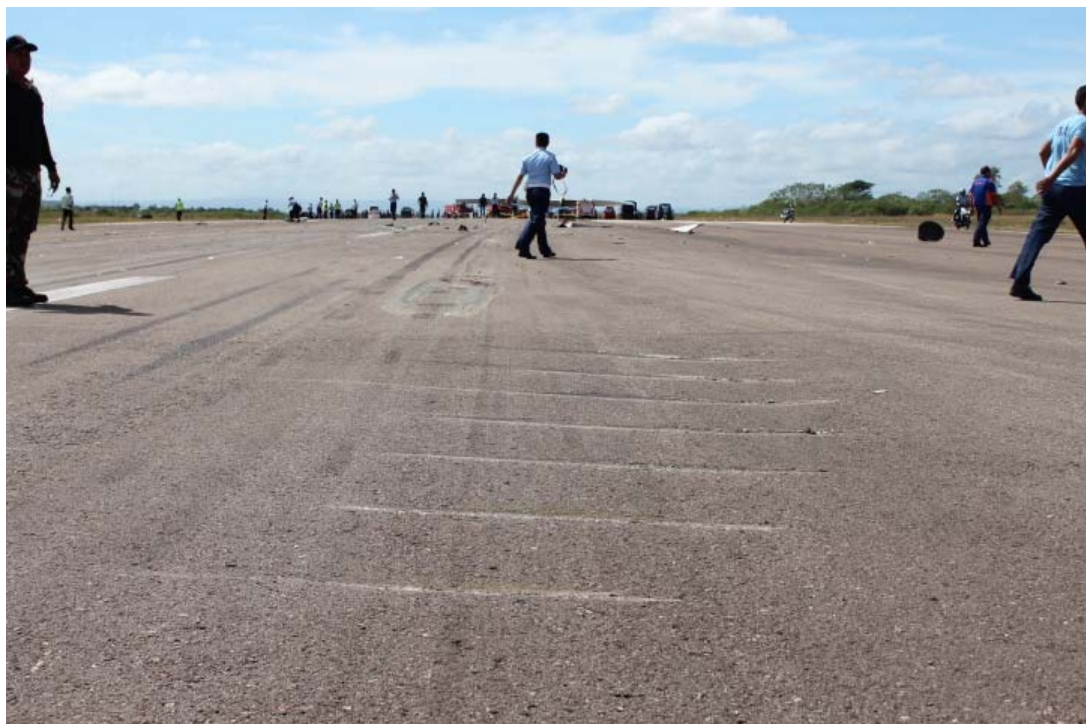
The propeller scratch marks were found on left and right side 13 meters of the main wheels marks.

Figure 13: The propeller scratch marks
